Basic Vehicle Condition Guide

Report ID: 17,798,946

Make: Model: Isuzu D-MAX **Body Style:** Utility Year: 2017 Registration: KLA812 Reg Expiry: 23 Jun 2019 **Odometer:** WoF Expiry: **Good No:** 24 Mar 2020 24,500 Kms 17798946 VIN: MPATFR85JGT003587 Next Service: 24,000kms Service History: Yes

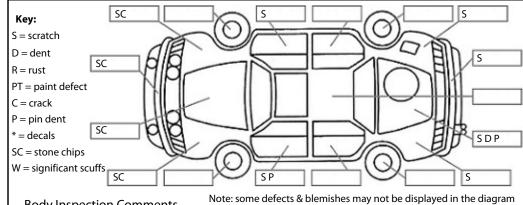
Two small stone cracks in right side of windscreen. Scratches in both right & left side tail light lenses.
