| Make: | Isuzu | Model: | Bighorn | Body Style: | Wagon |
| Year: | 1,993 | Registration: | ALL416 | Reg Expiry: | 22 Jun 2019 |
| WoF Expiry: | 10 Nov 2018 | Odometer: | 291,035 Kms | Good No: | 18344852 |

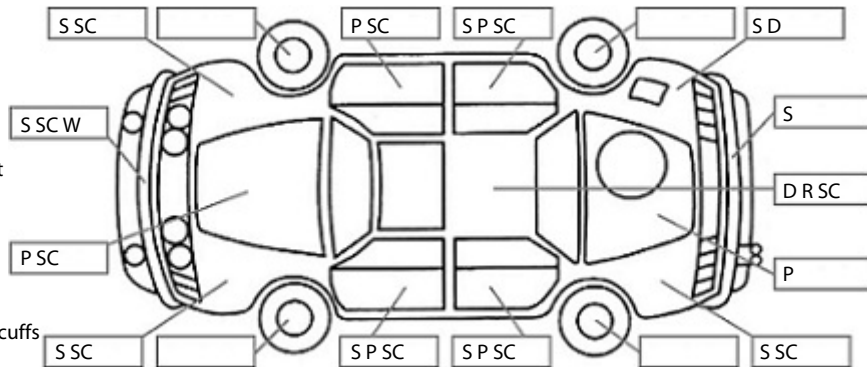
Moisture in RF indicator. Parking mirror on LF guard is broken. Aerial is broken. LF, RR and RF door weatherstrips are rusty. Rust in back edge of roof air deflector. RH C and D pillars have dents. RF door hinges are worn. Stonechips on windscreen. AC not cold. RH 3rd row seatbelt catch is damaged.
