| Make: | Subaru | Model: | Exiga | Body Style: | Wagon |
| Year: | 2009 | Registration: | LF5955 | Reg Expiry: | 06 Dec 2018 |
| WoF Expiry: | 10 Jan 2019 | Odometer: | 155,429 Kms | Good No: | 19119681 |

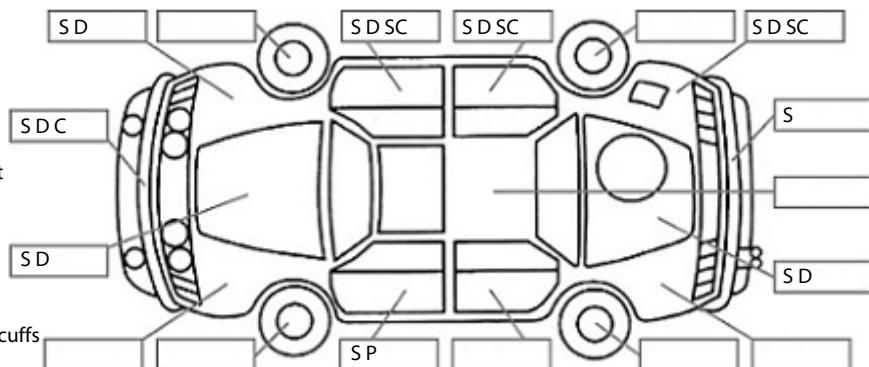
Moulding missing from bonnet, front bumper needs alignment, front windscreen broken, RF door mirror glass broken,
