| Make: | Isuzu | Model: | D-MAX | Body Style: | Utility |
| Year: | 2016 | Registration: | KEZ39 | Reg Expiry: | 07 Dec 2019 |
| VIN: | MPATFR85JGT003692 | Next Service: | 75924 | Service History: | No |

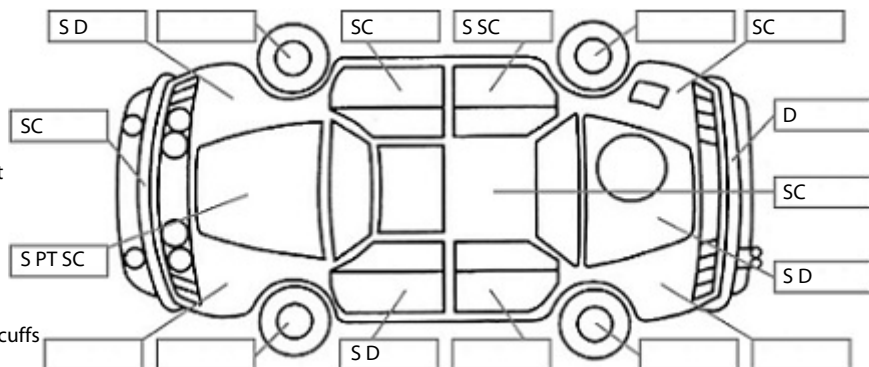
Minor stone chips in the windscreen ,
