Basic Condition Guide

•	Report ID:	21,385,348	Version:	2
	Created:	03 Dec 2025

,	
Make:	Ford	Model:	Ranger
Body Style:	Utility	Year:	2014
Rego No.:	HNY935	Rego Expiry:	23 Jan 2026
WoF Expiry:	07 Aug 2026	Odometer:	229,456 Kms
Good No.:	21385348	VIN:	MNAUMFF50EW275267
Next Service:	243,000	Service History:	No

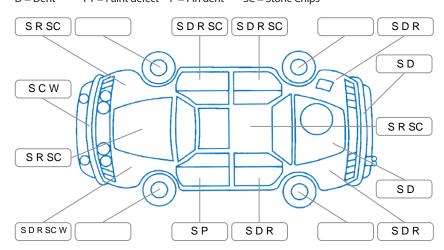
Large stone chips in windscreen

Antenna mount on roof. Antenna mount on side of cab

Dent in left cab corner. Minor dents in back of cab

Paint worn in drivers door sill
