Basic Condition Guide

•	Report ID:	22,925,390	Version:	2
	Created:	01 Dec 2025

Make:	Holden	Model:	Equinox
Body Style:	SUV	Year:	2018
Rego No.:	LNW815	Rego Expiry:	12 Dec 2025
WoF Expiry:	27 Nov 2026	Odometer:	121,779 Kms
Good No.:	22925390	VIN:	3G0AX7EX4JS600591
Next Service:	123,000 Kms	Service History:	Yes

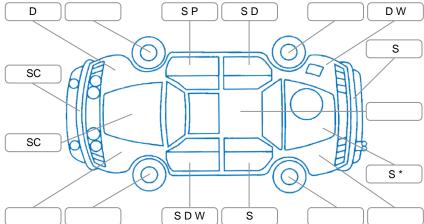
Left front door has model badge ripped off from dent impact. Windscreen has stone chip.
