Basic Condition Guide

•	Report ID:	26,049,735	Version:	1
	Created:	27 Nov 2025

Make:	Volkswagen	Model:	T5
Body Style:	Van	Year:	2011
Rego No.:	GAG198	Rego Expiry:	28 Jul 2026
WoF Expiry:	20 Dec 2025	Odometer:	173,375 Kms
Good No.:	26049735	VIN:	WV1ZZZ7HZBH104215
Next Service:	167,200km's	Service History:	No

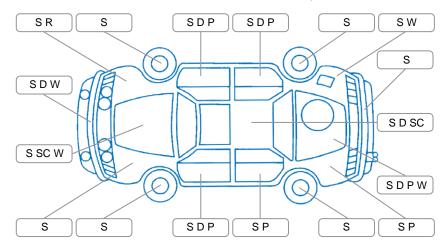
Water inside left side repeater indicator lens on left front guard. Large dents in right side rear sliding door
