# **Basic Condition Guide**

•	Report ID:	26,050,166	Version:	1
	Created:	17 Dec 2025

Make:	Mitsubishi	Model:	Triton
Body Style:	Utility	Year:	2019
Rego No.:	MGH96	Rego Expiry:	29 Jan 2026
WoF Expiry:	29 Jul 2026	Odometer:	163,999 Kms
Good No.:	26050166	VIN:	MMAYLKK10KH018525
Next Service:	162,000km's	Service History:	Yes

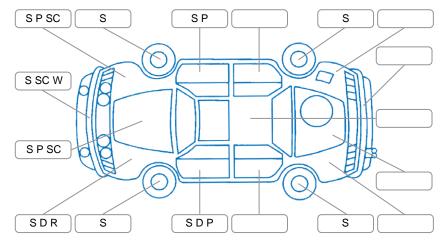
Left side plastic moulding cover missing off front bumper. Two small stone cracks in left side of windscreen, is a double hit close together & is not repairable.
