# **Basic Condition Guide**

Report ID:	26,068,959	Version:	1
Created:	25 Nov 2025

Make:	Toyota	Model:	Hiace
Body Style:	Van	Year:	2016
Rego No.:	JSK616	Rego Expiry:	26 Jan 2026
WoF Expiry:	27 Mar 2026	Odometer:	332,084 Kms
Good No.:	26068959	VIN:	JTFHT02PX00168904
Next Service:	346,000 Kms	Service History:	Yes

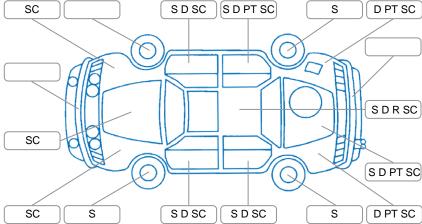
ĸey				
S = Scratch	R = Rust	C = Crack	* = Decals	W = Significant scuffs
D = Dent	PT = Paint defect	P = Pin dent	SC = Stone Chips

LR/RF door seals damaged. Tailgate badge missing.

Tailgate seal damaged. Holes drilled in inside of front doors. LH taillight broken. Stone chips in windscreen.

Highs stop light cracked. Step plates worn.
