•	Report ID: 26,082,622		Version:	3
	Created:	01 Dec 2025

Make:	Mitsubishi	Model:	Triton
Body Style:	Utility	Year:	2017
Rego No.:	KLA965	Rego Expiry:	09 Mar 2026
WoF Expiry:	15 Dec 2026	Odometer:	184,435 Kms
Good No.:	26082622	VIN:	MMAYYKK10HH001023
Next Service:	192,000 Kms	Service History:	Yes

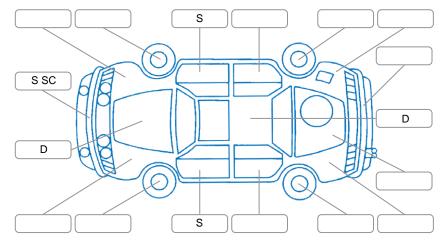
Front bumper detaching on sides
