•	Report ID:	27,077,302	Version:	7
	Created:	05 Dec 2025

,	
Make:	Toyota	Model:	Aqua
Body Style:	Hatchback	Year:	2016
Rego No.:	PAA811	Rego Expiry:	24 Jan 2026
WoF Expiry:	01 Aug 2026	Odometer:	161,643 Kms
Good No.:	27077302	VIN:	7AT0H65YX22532745
Next Service:	171,000	Service History:	Yes

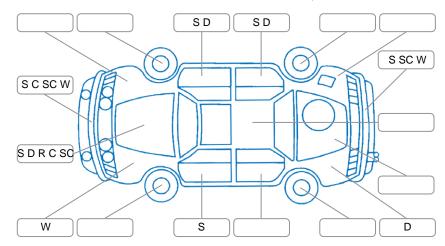
Front bumper damage Stone chips in front screen. Rear bumper poor fit. Stone chips and scratches all over
