| Report ID: | 27,164,000 | Version: | 1 |

| Make: | Isuzu | Model: | D-MAX |
| Body Style: | Utility | Year: | 2019 |
| Rego No.: | MPB740 | Rego Expiry: | 20 Dec 2025 |

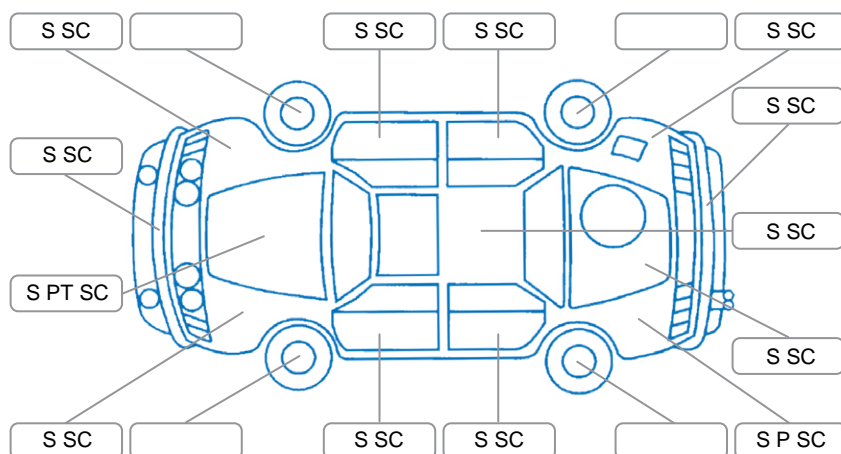
Note: some defects and blemishes may not be displayed in the diagram

Engine check light on further investigation needed/left mirror housing damaged/rr tail light smashed/
