•	Report ID:	27,169,051	Version:	1
	Created:	14 Nov 2025

Make:	Holden	Model:	Colorado
Body Style:	Utility	Year:	2012
Rego No.:	HUJ600	Rego Expiry:	08 Nov 2025
WoF Expiry:	14 Nov 2026	Odometer:	212,476 Kms
Good No.:	27169051	VIN:	MMU148FH0DH611122
Next Service:	218000 Kms	Service History:	No

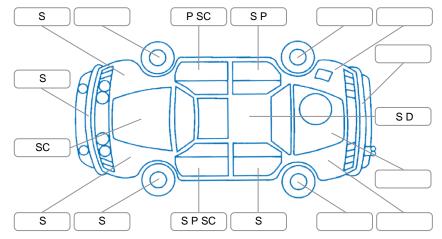
Roof aerial broken.
