# **Basic Condition Guide**

•	Report ID:	27,178,299	Version:	1
	Created:	23 Dec 2025

Make:	Subaru	Model:	Forester
Body Style:	SUV	Year:	2010
Rego No.:	FHR408	Rego Expiry:	17 Dec 2025
WoF Expiry:	14 May 2026	Odometer:	208,305 Kms
Good No.:	27178299	VIN:	JF2SH9KL5AG040981
Next Service:	218,200kms	Service History:	No

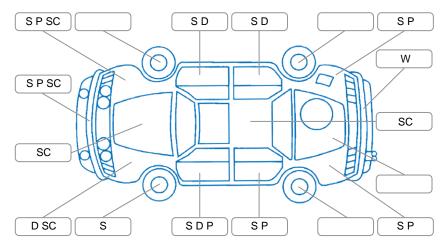
Left tail light is cracked.(Water in it). One of cargo anchor cover is missing.
