# **Basic Condition Guide**

•	Report ID:	27,785,431	Version:	1
	Created:	14 Nov 2025

Make:	Toyota	Model:	Hiace
Body Style:	Van	Year:	2008
Rego No.:	LHY207	Rego Expiry:	17 Jun 2025
WoF Expiry:	10 May 2025	Odometer:	208,259 Kms
Good No.:	27785431	VIN:	7AT0H60FX18081523
Next Service:	205,711kms	Service History:	No

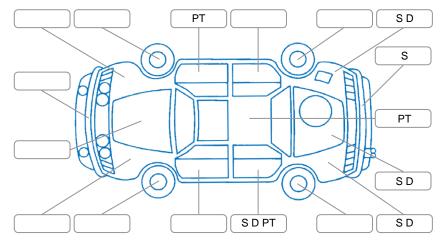
Note: some defects and blemishes may not be displayed in the diagram
