# **Basic Condition Guide**

•	Report ID: 27,792,415		Version:	1
	Created:	11 Dec 2025

Make:	Suzuki	Model:	Vitara
Body Style:	SUV	Year:	2017
Rego No.:	KKE296	Rego Expiry:	19 Feb 2026
WoF Expiry:	29 Sep 2026	Odometer:	172,500 Kms
Good No.:	27792415	VIN:	TSMLYE21S00302612
Next Service:	176300 Kms	Service History:	No

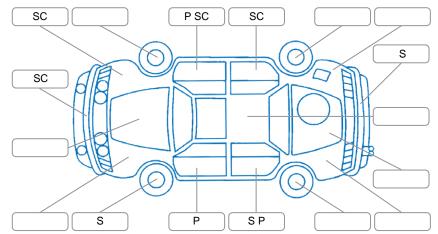
Note: some defects and blemishes may not be displayed in the diagram  $\,$
