# **Basic Condition Guide**

•	Report ID:	port ID: 27,801,414		4
	Created:	04 Dec 2025

Make:	Foton	Model:	Tunland
Body Style:	Utility	Year:	2014
Rego No.:	HSW910	Rego Expiry:	02 Dec 2025
WoF Expiry:	09 Oct 2026	Odometer:	124,180 Kms
Good No.:	27801414	VIN:	LVAV2MBB5EJ037334
Next Service:	134,180km	Service History:	No

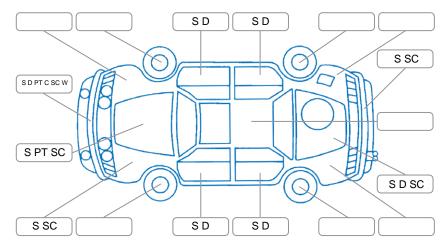
Paintwork's poor and faded with clear coat coming off in spots. Front bumper damaged. Lhs running board hanging down. Rear bumper poor fit.
