•	Report ID:	27,801,467	Version:	2
	Created:	27 Nov 2025

Make:	Subaru	Model:	Legacy
Body Style:	Wagon	Year:	2006
Rego No.:	LAE13	Rego Expiry:	10 Aug 2026
WoF Expiry:	17 Oct 2026	Odometer:	165,670 Kms
Good No.:	27801467	VIN:	7AT0GF0BX17041962
Next Service:	166,474 Kms	Service History:	No

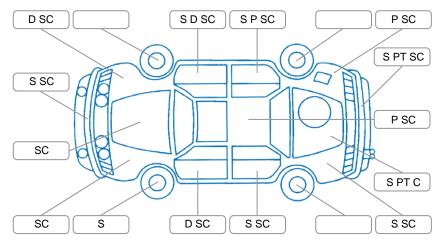
Paint defect on front grill. Paint defect on rear spoiler.
