Basic Condition Guide

•	Report ID:	Report ID: 27,804,529		1
	Created:	24 Nov 2025

T
Make:	Ford	Model:	Transit
Body Style:	Van	Year:	2023
Rego No.:	QCZ622	Rego Expiry:	23 Nov 2025
WoF Expiry:	20 Jul 2026	Odometer:	44,077 Kms
Good No.:	27804529	VIN:	WF0EXXTTRBNG18439
Next Service:	unknown	Service History:	No

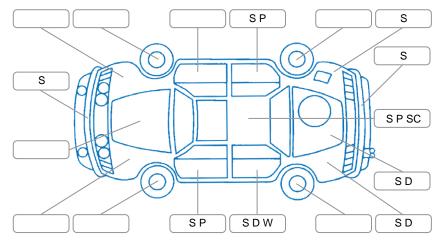
Left wing mirror indicator lens broken. Spare wheel missing.
Left tail light cracked. 2 wheel trims missing.

Left rear corner panel dented. Right wing mirror lower glass missing.
