Basic Condition Guide

| Make: | Honda | Model: | FIT Shuttle |
| Body Style: | Wagon | Year: | 2013 |
| Good No.: | 27810708 | VIN: | 7AT08G2YX24108909 |

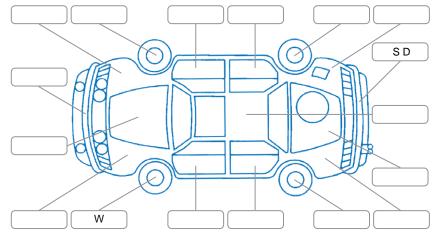
Note: some defects and blemishes may not be displayed in the diagram $\,$
