| Report ID: | 27,813,953 | Version: | 2 |

| Make: | Mazda | Model: | Atenza |
| Body Style: | Wagon | Year: | 2013 |

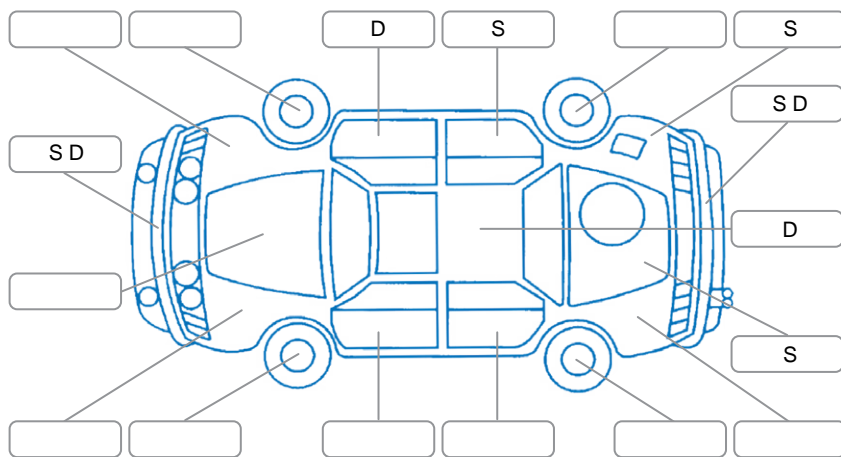
Note: some defects and blemishes may not be displayed in the diagram
