•	Report ID:	27,819,275	Version:	1
	Created:	02 Dec 2025

Make:	Toyota	Model:	Aqua	
Body Style:	Hatchback	Year:	2018	
Rego No.:	QUF618	Rego Expiry:	10 Mar 2026	
WoF Expiry:	13 Mar 2026	Odometer:	127,172 Kms	
Good No.:	27819275	VIN:	7AT0H65YX24752698	
Next Service:	no sticker	Service History:	No	
Note: This are out in a to a suppose to

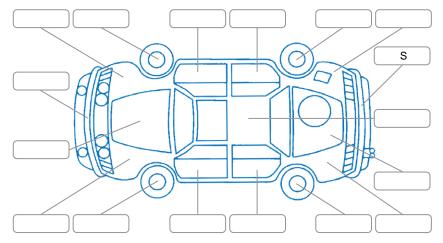
Passenger seat belt frayed, both rear tyre side wall cracked,L minor indicator lens cracked,
