•	Report ID:	27,820,288	Version:	1
	Created:	10 Dec 2025

Make:	Ford	Model:	Focus
Body Style:	Hatchback	Year:	2014
Rego No.:	HTS314	Rego Expiry:	25 Sep 2026
WoF Expiry:	04 Feb 2026	Odometer:	123,402 Kms
Good No.:	27820288	VIN:	MPB1XXMXB1EB85218
Next Service:	132,300kms	Service History:	Yes

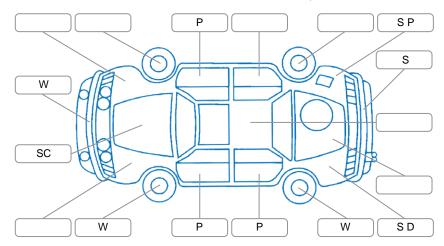
Left door mirror bezel is broken. Part of rear wiper arm is broken. (Operating). Small stone crack at right side edge of windshield.
