•	Report ID:	27,824,692	Version:	2
	Created:	05 Dec 2025

Make:	Toyota	Model:	Corolla
Body Style:	Hatchback	Year:	2006
Rego No.:	GSD384	Rego Expiry:	04 Jul 2026
WoF Expiry:	16 Dec 2026	Odometer:	138,349 Kms
Good No.:	27824692	VIN:	7AT0H607X12407112
Next Service:	148,300kms	Service History:	No

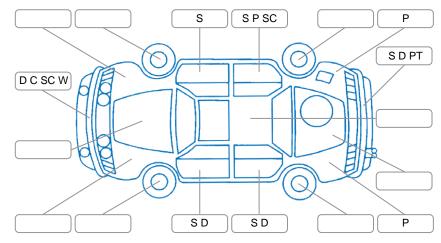
Paint is flaking on rear bumper. Both door mirrors paint is flaking. Minor stone cracks in left side of windshield.
