Basic Condition Guide

•	Report ID:	27,829,514	Version:	1
	Created:	31 Dec 2025

Make:	Mazda	Model:	Axela
Body Style:	Hatchback	Year:	2014
Rego No.:	QPR725	Rego Expiry:	22 Feb 2026
WoF Expiry:	18 Dec 2026	Odometer:	146,563 Kms
Good No.:	27829514	VIN:	7AT0C13JX24105772
Next Service:	156,550kms	Service History:	No

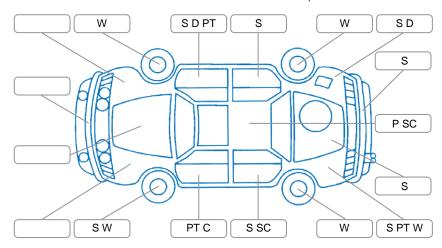
Tow hook cover missing off left side of rear bumper. Scratches in left side sill. Crack in left side wing mirror cover & paint is worn on cover.
