•	Report ID:	Report ID: 27,829,580		1
	Created:	04 Dec 2025

Make:	Hyundai	Model:	Santa FE
Body Style:	SUV	Year:	2015
Rego No.:	JAH786	Rego Expiry:	24 Dec 2025
WoF Expiry:	23 Oct 2026	Odometer:	286,568 Kms
Good No.:	27829580	VIN:	KMHSU81XSFU442275
Next Service:	294,000	Service History:	Yes

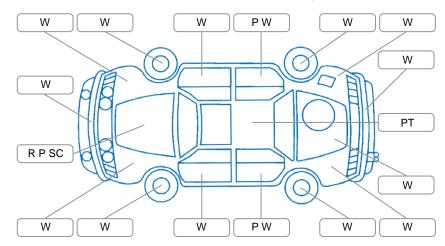
Right side mirror housing scuff Left taillight condensation
