Basic Condition Guide

-	Report ID: 27,830,086		Version:	2
	Created:	03 Dec 2025

Make:	Ford	Model:	Ranger
Body Style:	Utility	Year:	2014
Rego No.:	HSD252	Rego Expiry:	15 Feb 2026
WoF Expiry:	29 Aug 2026	Odometer:	154,650 Kms
Good No.:	27830086	VIN:	MNAUMFF50EW295568
Next Service:	160,776kms	Service History:	No

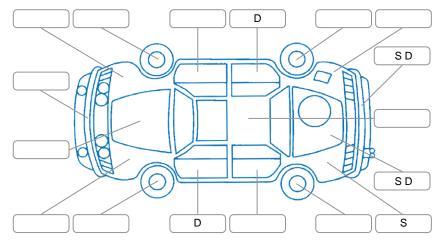
Note: some defects and blemishes may not be displayed in the diagram

Wiper blade torn, missing front headlight bulb, both rear wheel cap missing, high stop light not working, gear knob plastic cover missing. Both front wheel play, underbody rust, engine oil leak, steering rock leak.

R tail light damage.

Horn not working, steel wheel worn, both high beam not working, canopy paint defect, missing canopy key,
