Basic Condition Guide

Report ID:	Report ID: 27,843,905		2
Created:	19 Dec 2025

Make:	Nissan	Model:	Navara	
Body Style:	Utility	Year:	2008	
Rego No.:	ELH183	Rego Expiry:	31 Dec 2025	
WoF Expiry:	03 Dec 2026	Odometer:	262,978 Kms	
Good No.:	27843905	VIN:	VSKCVAD40A0269961	
Next Service:	272970 kms	Service History:	No	
Note: This report is	not a warranty		·	
This report is a guide only. Consideration is made for age and mileage. Parts have not been dismantled or diagnostic testing undertaken. The vehicle has been driven up to 50km/h from cold. The Vendor recommends a full mechanical inspection prior to purchase and this can be arranged for an additional charge.

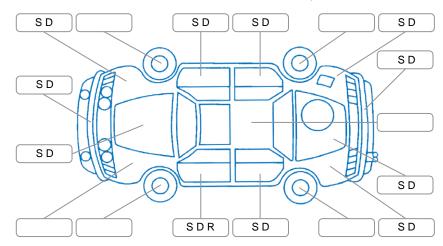
Body Inspection Comments

Both tail light cracked
