Basic Condition Guide

•	Report ID: 27,859,458		Version:	1
	Created:	18 Dec 2025

Make:	Nissan	Model:	Bluebird
Body Style:	Sedan	Year:	2007
Rego No.:	KBZ461	Rego Expiry:	19 Mar 2026
WoF Expiry:	01 Jan 2027	Odometer:	89,944 Kms
Good No.:	27859458	VIN:	7AT0DH1EX16064212
Next Service:	100,000 Kms	Service History:	No

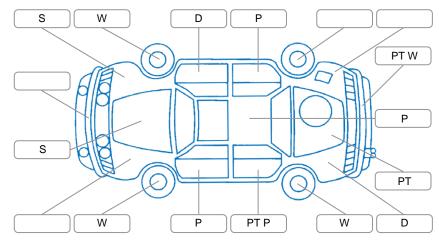
Surface rust in boot jamb Cracks in wheel hub caps Front left wing mirror damaged
