•	Report ID:	27,878,732	Version:	1	
	Created:	22 Dec 2025

Make:	Mazda	Model:	Axela
Body Style:	Wagon	Year:	2013
Rego No.:	MYG881	Rego Expiry:	28 Dec 2025
WoF Expiry:	15 Dec 2026	Odometer:	124,649 Kms
Good No.:	27878732	VIN:	7AT0C13JX20208151
Next Service:	134,600 Kms	Service History:	No

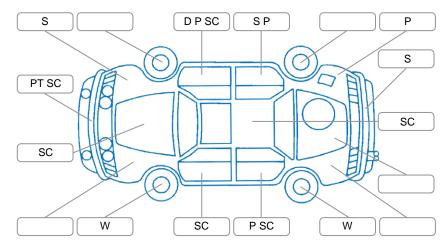
Moisture in left rear boot lid taillight
