Report ID:	27,879,182	Version:	1
Created:	23 Dec 2025

Make:	Mazda	Model:	Bt-50
Body Style:	Utility	Year:	2014
Rego No.:	RNM271	Rego Expiry:	15 Jun 2026
WoF Expiry:	16 Dec 2026	Odometer:	172,553 Kms
Good No.:	27879182	VIN:	MM0UP0YF100225660
Next Service:	no sticker	Service History:	No

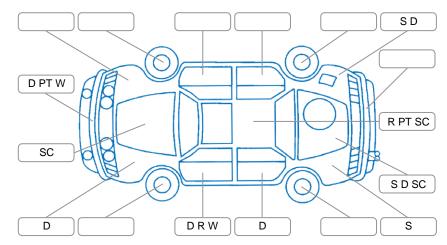
Front bumper misaligned

Condensation in both reverse lights and left taillight

Holes and rust in ute tray

Missing rear make and model badges

Right sill dented
