Basic Condition Guide

•	Report ID:	27,884,280	Version:	1
	Created:	24 Dec 2025

Make:	Toyota	Model:	Hilux
Body Style:	Wagon	Year:	1994
Rego No.:	CLJ556	Rego Expiry:	29 Mar 2026
WoF Expiry:	19 May 2026	Odometer:	184,462 Kms
Good No.:	27884280	VIN:	7A8H60G0704061811
Next Service:	187,000kms	Service History:	No

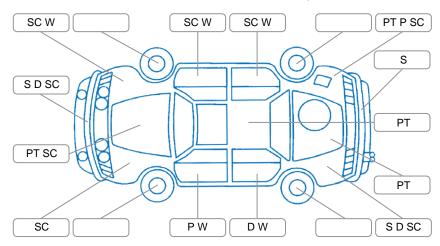
F/L park light cracked & not working.

F/R indicator lens cracked.

Aerial broken.
