Basic Condition Guide

•	Report ID: 27,886,190		Version:	1
	Created:	28 Dec 2025

Make: Mazda		Model:	Atenza
Body Style:	Wagon	Year:	2010
Rego No.:	LST704	Rego Expiry:	23 Apr 2026
WoF Expiry:	01 Dec 2026	Odometer:	176,188 Kms
Good No.:	27886190	VIN:	7AT0C139X18202010
Next Service:	183900	Service History:	No

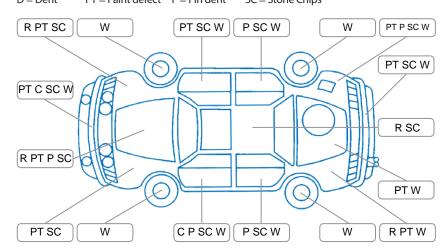
Note: some defects and blemishes may not be displayed in the diagram

Paint rough

R fog light cracked

Front bumper misaligned
