| Report ID: | 28,328,681 | Version: | 2 |

| Make: | Mitsubishi | Model: | Lancer |
| Body Style: | Sedan | Year: | 1992 |

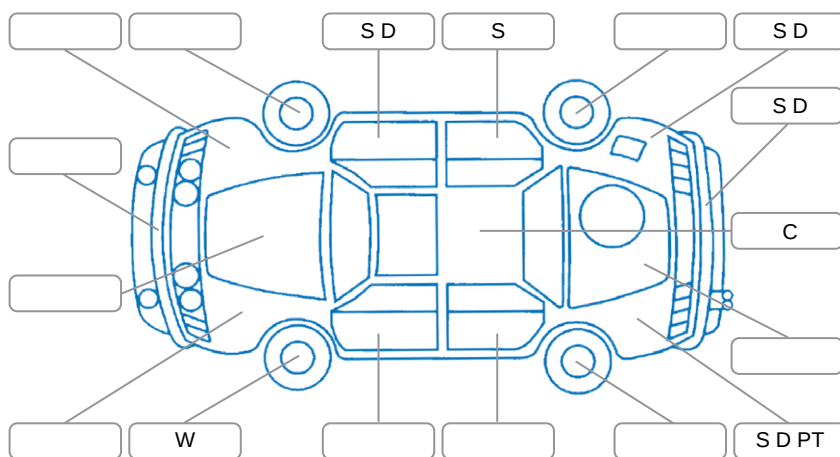
S = Scratch R = Rust C = Crack \* = Decals W = Significant scuffs  
D = Dent PT = Paint defect P = Pin dent SC = Stone Chips

Note: some defects and blemishes may not be displayed in the diagram
