<b>Make:</b>	Foton	<b>Model:</b>	View CS2	<b>Body Style:</b>	Van
<b>Year:</b>	2016	<b>Registration:</b>	LAT177	<b>Reg Expiry:</b>	21 May 2024
<b>WoF Expiry:</b>	22 Aug 2024	<b>Odometer:</b>	106,000 Kms	<b>Good No:</b>	25686444
<b>VIN:</b>	LVAC2ZBB8FS044522	<b>Next Service:</b>	no service history	<b>Service History:</b>	No

**Body Inspection Comments**

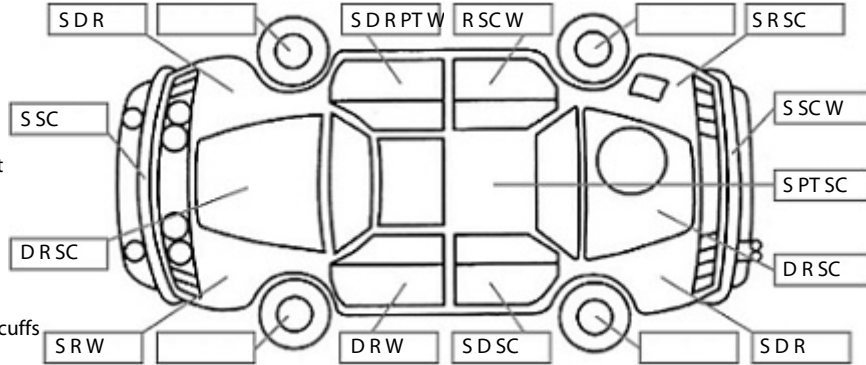
Lh headlight and tail light scuffed.

Oil leaks. Major damage to rhr of vehicle is structural. Tailgate vision mirror missing. Bits of decals on body. Both front tyres have excessive edge wear. Clutch a slave cylinder worn. Radiator support bent
