Report ID: 17,401,627

Make: Model: **Body Style:** SUV Toyota Highlander Year: Registration: **Reg Expiry:** 2,007 **DRZ126** 16 Apr 2018 **WoF Expiry: Odometer: Good No:** 08 Jun 2018 239,481 Kms 17401627 VIN: **Next Service: Service History:** JTEHP21A700166951 240000 No

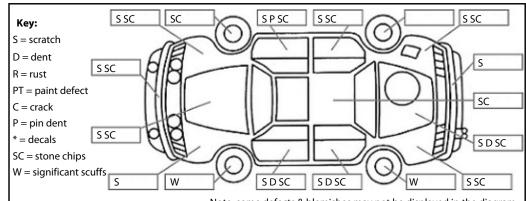
Body Inspection Comments

Note: some defects & blemishes may not be displayed in the diagram

Stonechips on windscreen. Headlamps need buffing. Rear bumper not secure. Paint damage on front bumper. All seats have marks. No wheel brace. RF seat is worn. Remote locking not working.
