<b>Make:</b>	Mazda	<b>Model:</b>	Atenza	<b>Body Style:</b>	Sedan
<b>Year:</b>	2005	<b>Registration:</b>	GZB921	<b>Reg Expiry:</b>	13 Aug 2020
<b>WoF Expiry:</b>	18 Apr 2020	<b>Odometer:</b>	232,370 Kms	<b>Good No:</b>	17655264
<b>VIN:</b>	7AT0C139X13402872	<b>Next Service:</b>		<b>Service History:</b>	No

## Body Inspection Comments

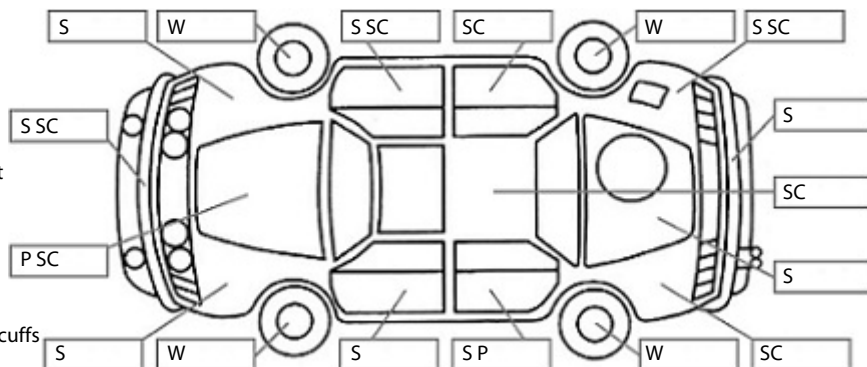
Suntan lotion damage on paint. LH inner taillight has moisture. Water in spare wheel well. LR wheel has no center cap. Badge missing on tailgate. Stonechips on windscreen. Aerial damaged. RH air vent of the three in center of dash is damaged. Jack cover damaged. Wear on RF seat.
