Make:	Ford	Model:	Telstar	Body Style:	Wagon
Year:	1990	Registration:	PB5864	Reg Expiry:	25 Oct 2019
WoF Expiry:	15 Nov 2019	Odometer:	247,499 Kms	Good No:	17703334
VIN:		Next Service:		Service History:	No

Body Inspection Comments

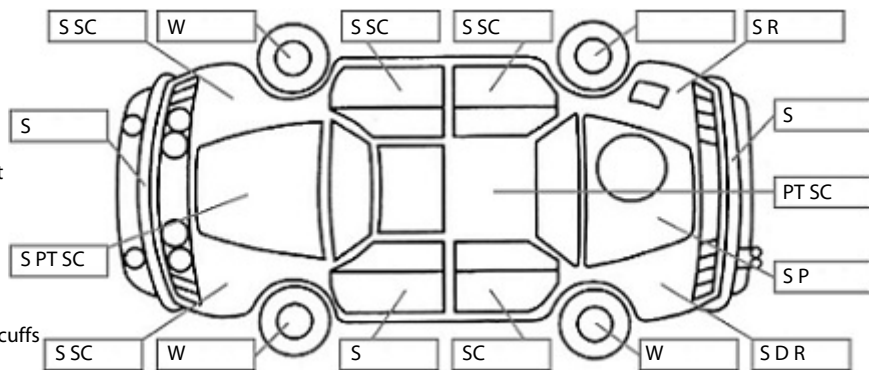
Paint is worn. Poor paint touchups and overspray all over vehicle. Filler in LF guard. LF door key barrel not working. Rust on LR and RR wheel arches. Rust under tailgate rubber. Wear on RF door card. Wiring loose behind LHS of center console. Some surface rust in spare wheel well.
