Basic Vehicle Condition Guide

Make: Model: Nissan Maxima **Body Style:** Sedan Year: 2008 Registration: EGE302 **Reg Expiry:** 30 Jul 2019 WoF Expiry: **Odometer:** 19 Feb 2020 235,678 Kms **Good No:** 17703404 VIN: JN1BBUJ31A0301705 **Next Service:** Service History:

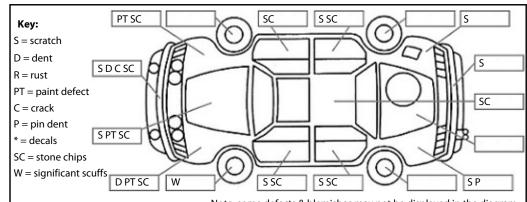
Body Inspection Comments

Note: some defects & blemishes may not be displayed in the diagram

Small rust spots both back guards above taillights under boot lid. Suntan lotion damage on paint. Stonechips on windscreen. Front bumper damaged.

AC not cold. Boot board broken. Paint fading on all door window frames. Rust in RF door above top hinge. Wear on RF seat and steering wheel.
