| Make: | Ford | Model: | Transit | Body Style: | Van |
| Year: | 2012 | Registration: | GQE594 | Reg Expiry: | 06 Apr 2019 |

Body Inspection Comments

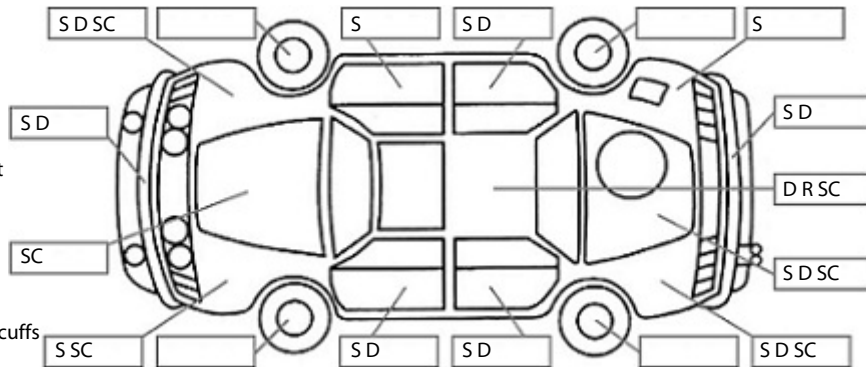
Lower door striker mounting panel damaged for rear doors. Trim missing below fuel filler lid. Outer handle not working on RH sliding door. RF guard damaged. Water damage to boards inside cargo area LR. Trim inside RH sliding door damaged. RF door rubber damaged. RF seat and RF floor mat is worn.
