Basic Vehicle Condition Guide

Make: Model: Hyundai Santa FE **Body Style:** SUV Year: 2016 Registration: JWR167 Reg Expiry: 31 Dec 2019 WoF Expiry: **Odometer:** 31 Oct 2020 49,822 Kms **Good No:** 17781709 VIN: KMHST81XSGU612938 Next Service: 64,000kms **Service History:** Yes

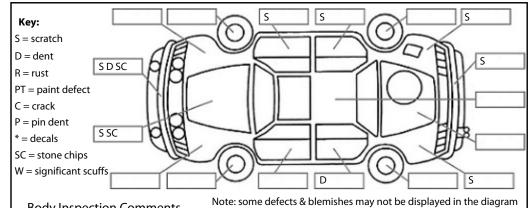
Body Inspection Comments

- Right front inner plastic guard panel is missing.
- Lower plastic panel in front bumper is not fitting correctly.
- Indicator lens in left side wing mirror is cracked & broken.
