| Make: Nissan | Model: Sunny | Body Style: Sedan |
| Year: 2004 | Registration: EYZ654 | Reg Expiry: 30 Apr 2020 |
| VIN: 7A8DH140709395520 | Next Service: 196,703kms | Service History: No |

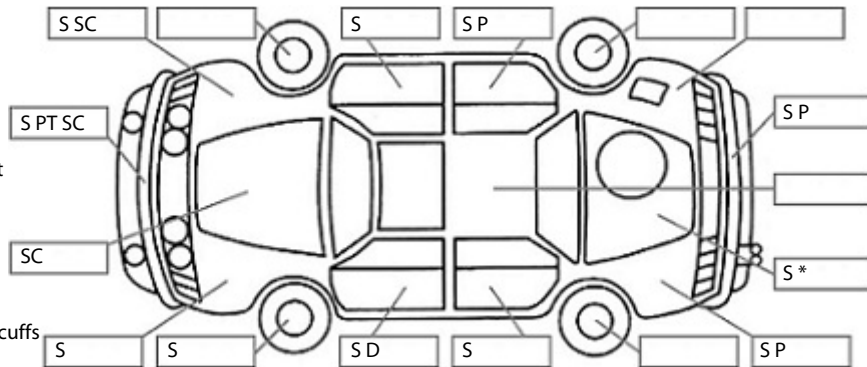
Body Inspection Comments

- Plastic interior trim missing on inside of right rear door.
- Small hole in front bumper.
- 2 x Small stone cracks in windscreen.
- Left side wing mirror cover has a bit broken off it.
- Monsoon shield on left front door is broken.
