| Make: | Toyota | Model: | Landcruiser | Body Style: | Wagon |
| Year: | 1,996 | Registration: | DDN507 | Reg Expiry: | 21 Jun 2018 |

Note: This report is not a warranty

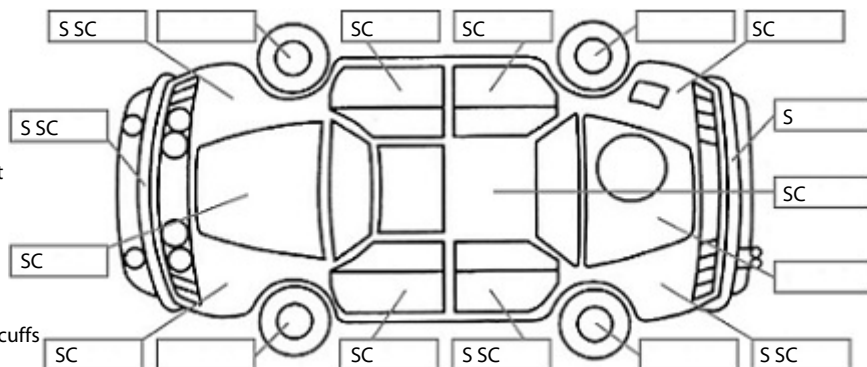
Body Inspection Comments

Aerial not working. Stonechips and wiper scratch on windscreen. RH mirror damaged. Taillights and numberplate lights not working. Console lid broken. Gear indicator by gear lever is damaged. Steering wheel rattles when turned. Heater fan is noisy. Tray under heater controls is damaged.
