<b>Make:</b>	Mazda	<b>Model:</b>	Atenza	<b>Body Style:</b>	Sedan
<b>Year:</b>	2,004	<b>Registration:</b>	FZZ312	<b>Reg Expiry:</b>	07 Jul 2018
<b>WoF Expiry:</b>	18 Jul 2018	<b>Odometer:</b>	202,502 Kms	<b>Good No:</b>	18097920
<b>VIN:</b>	7AT0C13JX11116686	<b>Next Service:</b>	211000	<b>Service History:</b>	No

**Body Inspection Comments**

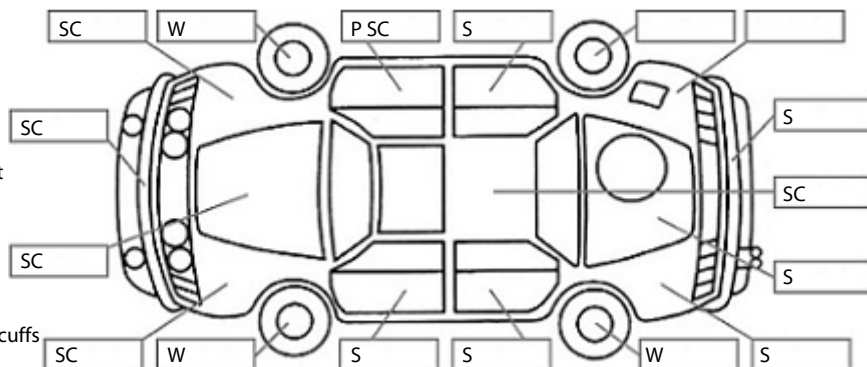
S = scratch  
D = dent  
R = rust  
PT = paint defect  
C = crack  
P = pin dent  
\* = decals  
SC = stone chips  
W = significant scuffs

Note: some defects & blemishes may not be displayed in the diagram

Stonechips on windscreen. Headlamps need buffing.  
Damage on dash pad. Marks on console. LH sunvisor broken. Wear on RF seat. Marks on all seats.  
Compartment lid on RHS of dash not staying shut.
