| <b>Make:</b> | Ford | <b>Model:</b> | Focus | <b>Body Style:</b> | Hatchback |
| <b>Year:</b> | 2,001 | <b>Registration:</b> | EWH75 | <b>Reg Expiry:</b> | 31 Aug 2018 |

## Note: This report is not a warranty

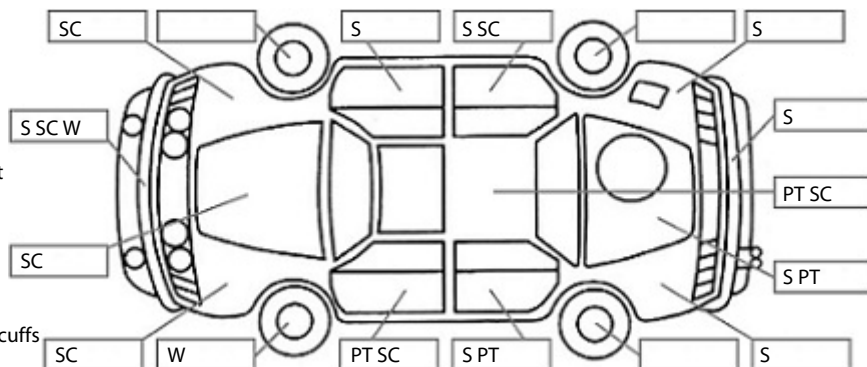
## Body Inspection Comments

Note: some defects & blemishes may not be displayed in the diagram

Clearcoat is coming off vehicle. Paint missing on LH mirror.

Remote locking not working. Rust and water in spare wheel well, also spare wheel retaining bolt bracket has rusted off floor. Rust on jack and tools. Paint coming off roof and top of tailgate. Stonechips on windscreen.
