<b>Make:</b>	Nissan	<b>Model:</b>	Terrano	<b>Body Style:</b>	Wagon
<b>Year:</b>	1,997	<b>Registration:</b>	BKW658	<b>Reg Expiry:</b>	09 Feb 2019
<b>WoF Expiry:</b>	13 Dec 2018	<b>Odometer:</b>	161,745 Kms	<b>Good No:</b>	18303766
<b>VIN:</b>	7A8DH2B0703016570	<b>Next Service:</b>		<b>Service History:</b>	No

## Body Inspection Comments

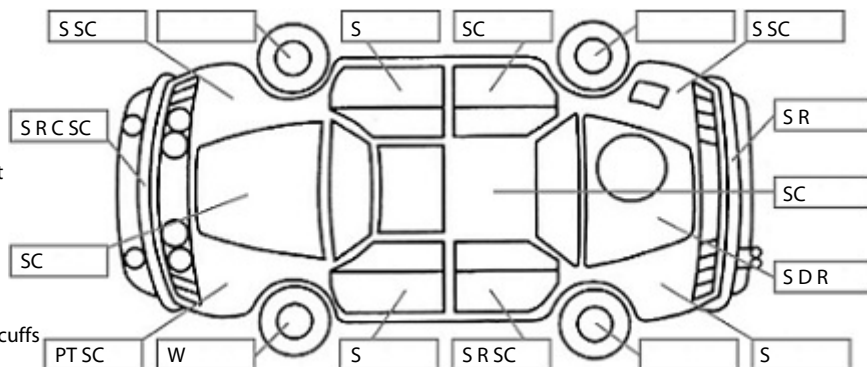
S = scratch  
D = dent  
R = rust  
PT = paint defect  
C = crack  
P = pin dent  
\* = decals  
SC = stone chips  
W = significant scuffs

Paint damage LF and LR flares. Clearcoat is coming off vehicle. LH sill has large dent. Running boards are very rusty. LR door has rust around Weatherstrip. Tailgate and rear bumper are rusty. Crack in RH mirror body. Stonechips on windscreen. Damage on front bumper and toe eye cover missing.
