<b>Make:</b>	Nissan	<b>Model:</b>	Primera	<b>Body Style:</b>	Sedan
<b>Year:</b>	2,000	<b>Registration:</b>	ZL1688	<b>Reg Expiry:</b>	14 Jan 2019
<b>WoF Expiry:</b>	22 Sep 2018	<b>Odometer:</b>	156,163 Kms	<b>Good No:</b>	18322261
<b>VIN:</b>	JN1BCAP11A0202632	<b>Next Service:</b>		<b>Service History:</b>	No

## Body Inspection Comments

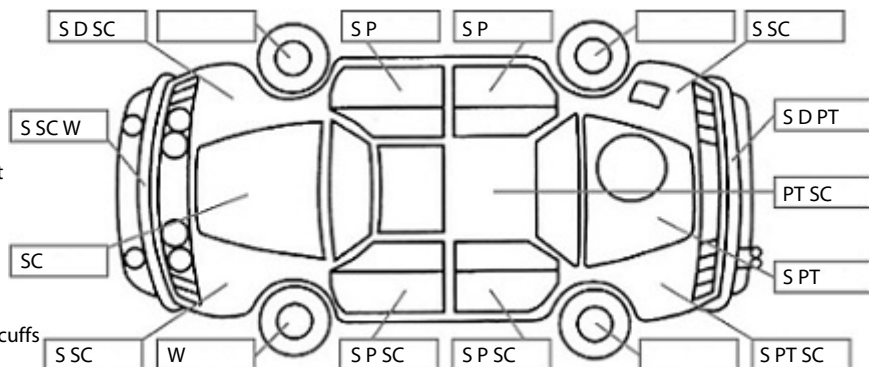
LF guard liner and mudflap not secure. Clearcoat is coming off vehicle. Rear bumper not fitting correctly RHS. Boot carpet, boot board and trim over boot lock are dirty or damaged. Aerial broken. RF door hinges worn. Front bumper not fitting correctly RHS. Bonnet protector worn. Marks on rear seat.
