<b>Make:</b>	Nissan	<b>Model:</b>	Altima	<b>Body Style:</b>	Sedan
<b>Year:</b>	2015	<b>Registration:</b>	LPW261	<b>Reg Expiry:</b>	28 Sep 2018
<b>WoF Expiry:</b>		<b>Odometer:</b>	112,863 Kms	<b>Good No:</b>	18327378
<b>VIN:</b>	MNTBCAL33A000002	<b>Next Service:</b>	100,000kms	<b>Service History:</b>	No

## Body Inspection Comments

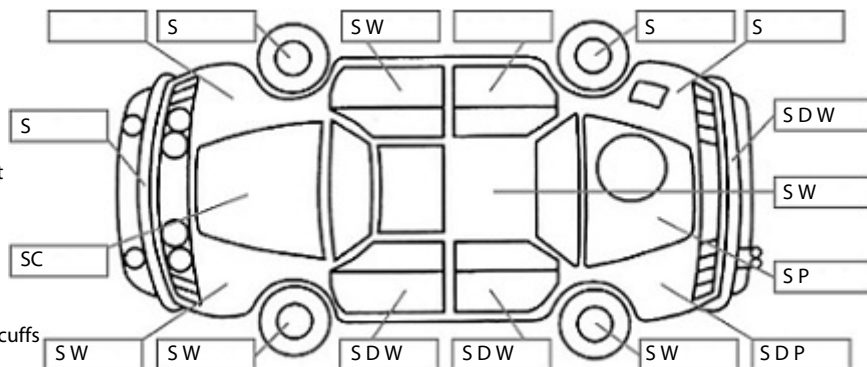
Small stone crack in middle of windscreen. Stone chips in windscreen. Large dent in left rear door & left rear guard. Small impact damage to rear bumper. Scratches & scuffs along left side sill. Left front tyre tread depth below legal limit, needs replaced.

Large dent in left rear door & left rear guard wheel arch. Wheel arch would need repaired to pass a w.o.f. Lock button not working on key remote. Battery in key remote will need replaced soon. Central lock only working from switch inside drivers door.
