<b>Make:</b>	Hyundai	<b>Model:</b>	Sonata	<b>Body Style:</b>	Sedan
<b>Year:</b>	2,008	<b>Registration:</b>	ENL687	<b>Reg Expiry:</b>	09 Dec 2018
<b>WoF Expiry:</b>	18 Aug 2019	<b>Odometer:</b>	85,377 Kms	<b>Good No:</b>	18329811
<b>VIN:</b>	KMHET41VR7A412242	<b>Next Service:</b>	89413	<b>Service History:</b>	No

## Body Inspection Comments

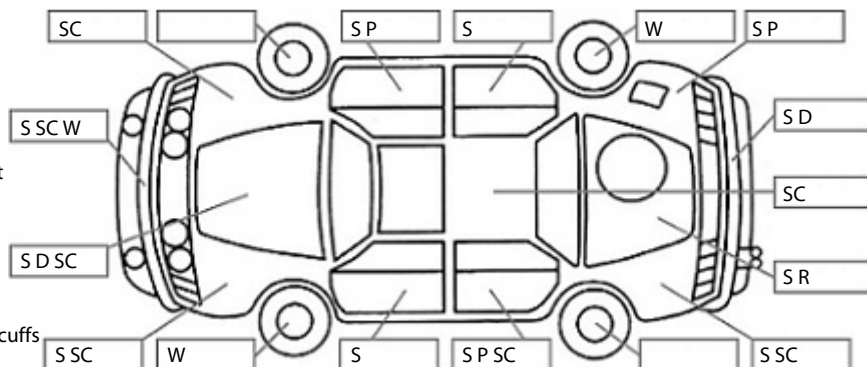
S = scratch  
D = dent  
R = rust  
PT = paint defect  
C = crack  
P = pin dent  
\* = decals  
SC = stone chips  
W = significant scuffs

Note: some defects & blemishes may not be displayed in the diagram

Paint damage on LF outer door handle. Rust on LH edge of boot lid and LR guard from aerial. Damage on RH mirror body. Stonechips on windscreen. Screw holes in console. Parts missing in console and dash. Wear on steering wheel and RH door card. Wear on RF seat.
