<b>Make:</b>	Toyota	<b>Model:</b>	Estima	<b>Body Style:</b>	People Mover
<b>Year:</b>	2,000	<b>Registration:</b>	DSG800	<b>Reg Expiry:</b>	21 Sep 2018
<b>WoF Expiry:</b>	23 Feb 2019	<b>Odometer:</b>	325,236 Kms	<b>Good No:</b>	18333433
<b>VIN:</b>	7A8H61Y0706012978	<b>Next Service:</b>	325800	<b>Service History:</b>	No

## Note: This report is not a warranty

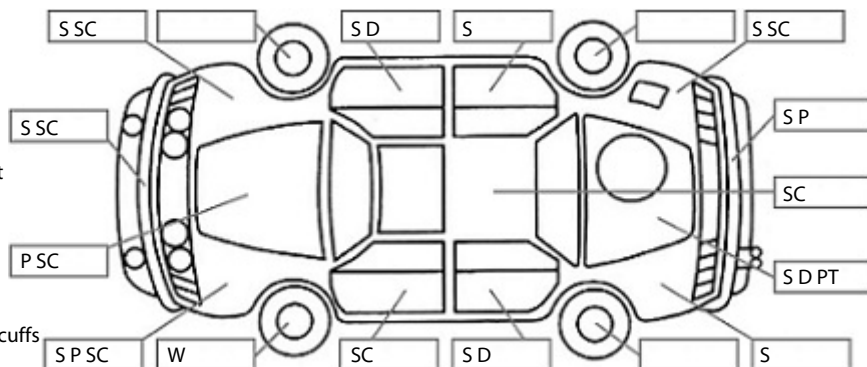
S = scratch  
D = dent  
R = rust  
PT = paint defect  
C = crack  
P = pin dent  
\* = decals  
SC = stone chips  
W = significant scuffs

Note: some defects & blemishes may not be displayed in the diagram

Moisture in LR indicator. Both RH wheels missing center caps. All window track rubbers on doors are damaged. LH sliding door difficult to open. Carpet in cargo area has marks. No jack or tools. Headlamp lenses need buffing.  
LF inner door handle worn. RF seat and seatbelt are worn. AC not cold.

Both sills have damage on seam . RF door has damage underneath. Baffle in rear muffler is loose. Clearcoat is coming off vehicle.
